And the second s	CENTRAL INTELLIGEN	CE AGENCY	
	INFORMATION	REPORT	
COUNTRY Hungar			DATE DISTR. 9 Jul 199
SUBJECT Budaor	s Airfield		NO. OF PAGES 3
			110. 07 TAGES
PLACE			NO. OF ENCLS. 1
ACQUIRED			(LISTED BELOW) (A)
DATE			SUPPLEMENT TO
ACQUIRED			REPORT NO.
DATE OF INFORMA	TION		
THIS DOCUMENT CONTAINS INTO	MATION APPROVING THE PAYORAL AUTORIA	• .	•
	THE MEANING OF TITLE 18, SECTIONS 703		•
AND 784, OF THE U.S. CODE, A LATION OF ITS CONTESTS TO SE	RESERVED. ITS TRANSMISSION OR REVE-	THIS IS UN	EVALUATED INFORMATION
ADD 794, PP THE W.A. EDIES, LATION OF ITS CONTEST TO GO PROBLETTED BY LAY, THE DIP!	PARENTS. 175 TRANSMIRION OR REVE- BERGIFF OF AN UNAUTHORIZE PERSON IS SOCRTION OF THIS FORM IS PROMISETED.	THIS IS UN	EVALUATED INFORMATION

ENCLOSURE (A): A sketch of Budaors Airfield Area.

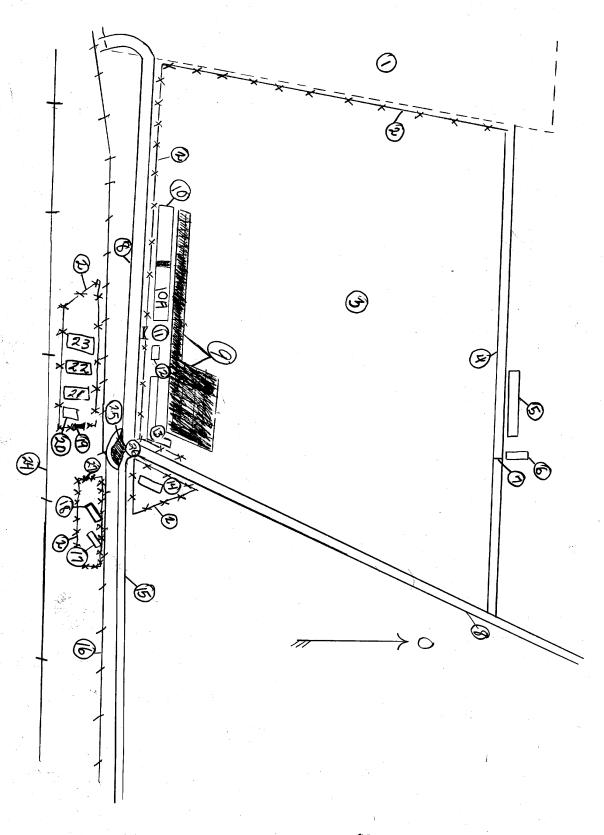
A SKETCH OF BUDAORS AIRFIELD AREA

the efficiency of the guards was only fair. Everyone entering or leaving the airfield had to show a pass.
- at the airfield there were only prewar air raid shelters constructed of concrete in the hillside about 500 meters from the field. There were no blast pens for aircraft, no anti-aircraft installations, no searchlights or aircraft detection equipment at the field. There were two fire fighting trucks equipped with 3,000 liter containers with chemical fire extinguishing material liquid, (Habolto-Por). The hangars and shops were equipped with five liter and ten liter chemical fire fighting liquid containers, hanging on walls. The firemen had a three months training course in Budapest before being assigned to the airfield.
- 7. The points hereunder refer to sketch, Enclosure (A):

- #1...... Village of Budaors, population about 4,000. There are no industrial installations in this village.
- #2..... Barbed wire fence which surrounds part of the airfield and three compounds belonging to the airfield. The wire is about two meters high, and supported by concrete posts, spaced at four meter intervals.

- #3..... Grass covered landing area.
- #4...... Gravel-covered road about three meters wide which leads to the western end of the airfield.
- #5..... Hangar used as storage place for old YAK-9 aircraft (without engines). The second floor is used for officers of the engineering section. This building is brick construction with four, reinforced concrete beams. On the southern side of the building there is a double, corrugated iron door, the same size as the side of the hangar. It is about 40 meters long and about 20 meters high. The building is light yellow. The second story has six windows on both of the long sides and three windows on the other two sides. The hangar section has three large windows on the long side and two windows on the other sides.

- #6...... Guards quarters, single story, constructed of brick. It has a gabled, red tile roof, about ten meters long, four meters wide and five meters high. The color of the building is dark yellow.

- #7..... Iron gate, about two meters high and three meters wide.
- #8..... Budapest-Balaton Lake Highway.
- #9..... Apron and taxi strip constructed of concrete blocks. The taxi strip is 130 meters long and four meters wide. The apron is about 20 meters square.

- #10..... Single story hangar, about 30 meters long, 15 meters wide and six meters high. It is constructed of bricks with four, reinforced contrete supports. The northern side has a corrugated, double door of dark green. The building is yellow.

- #10A.... Hangar constructed like the one described in point #10.
- #11..... Iron gate about two meters high, six meters wide and used by vehicles and pedestrians.

- #12..... Single story, brick building used for storage of mechanics' tools. It is about six meters long, four meters wide and four meters high. It has a gabled red tile roof. The color of the building is yellow.

•
#13	Office building, housing the Operations Section, Secret Service and the headquarters of the Hungarian Air Force Chief Engineer, Lt Col Kalman Horvate. The building is three stories high, constructed of brick and reinforced by concrete supports. The roof is flat, covered with gray slate, and is supported by reinforced concrete transversal
	beams. The control tower is round, five meters in diameter and projects about ten meters above the roof. The roof of the control tower is flat and covered with gray slate. The building is 40 and 20 meters
	long, 20 meters wide and 25 meters high.

#14	Three story brick building, about 20 meters long, nine meters wide and 20 meters high. The first and third floors are used as quarters for enlisted men; the second floor houses the squadron and flight engineer-
	ing officers' school.
<i>#</i> 15	Granite road to Budapest, about five meters wide.

#16	Double track, European, standard-gauge railroad, Budapest-Vienna.
#17	Three story, brick building, about 30 meters long, 20 meters wide and
	20 meters high. It has a gabled, red tile roof.

#18	Building, constructed like the one described in Point #17. It is used
-	as a recreation center for airfield personnel. Classrooms for the
,	engine and aircraft mechanics are located on the two upper floors.

#19	Iron gate, two meters high and six meters wide, used by vehicles and
	pedestrians.
#20	One story guard house, constructed of brick, about ten meters long,
	four meters wide and five meters high. It has a gabled, red tile roof.

#21	Three story, brick building, 30 meters long, 12 meters wide and 25
	meters high, used as quarters for the students at the airfield training center. It has a gabled, red tile roof.

#22	Building, used as quarters for students, constructed like the building
,,	described in Point #21. It also houses the medical dispensary.
#23	Building, used as quarters for students, same construction as the
,, ,	buildings described in Points #21 and #22.

#24	Double track streetcar line from Budapest to Torokealint.
#25	Bus stop.
#26 & 27.	Iron gates, two meters high and six meters wide.
